**REHABILITATION OF THE SUROOR
ELEMENTARY SCHOOL
UNDER THE ECONOMIC SUPPORT FUND
HUSSEINIYA, IRAQ**

SUSTAINMENT ASSESSMENT

**SIGIR PA-08-135
APRIL 7, 2009**

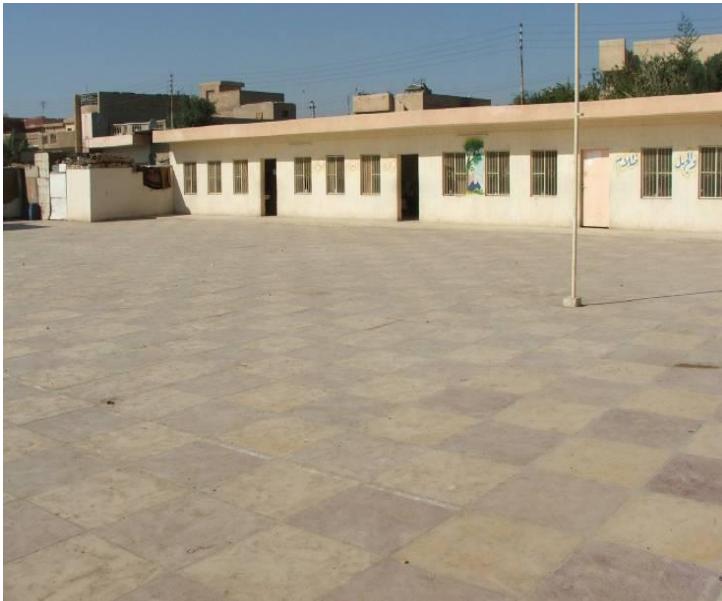
During the site visit, SIGIR identified the new walkway tiles for the school (Site Photo 5). While many windows were replaced, SIGIR noticed at least one instance where a screen was damaged (Site Photo 6); however, it was not clear whether the screen was poorly installed or subsequently damaged. In addition, SIGIR observed painted murals on several school walls (Site Photo 6).

Site Photos 5. New walkway tiles

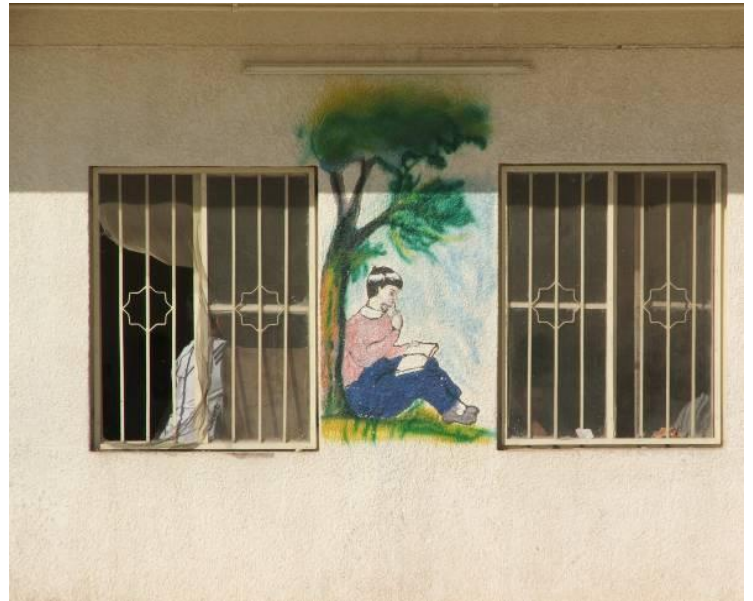
Site Photo 6. Broken screen and new wall mural

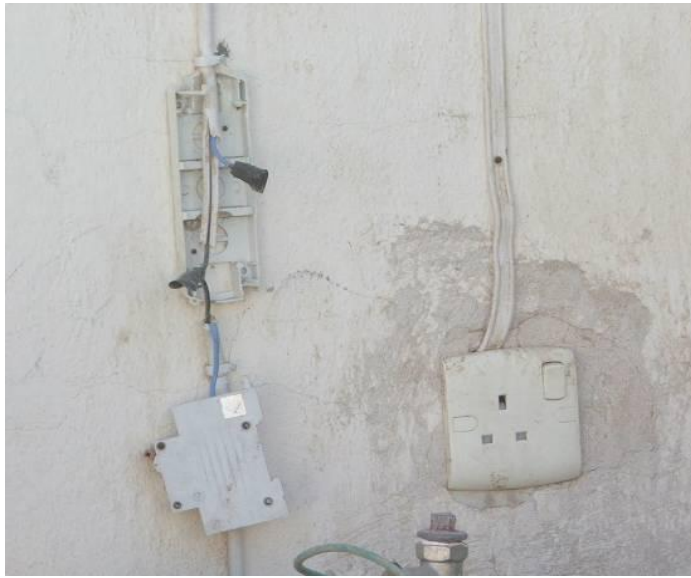
During the site visit, SIGIR identified unsafe electrical wiring and outlets; however, it appeared that someone tampered with the electrical wiring and outlets (Site Photo 7). Also, it did not appear that the contractor corrected existing electrical and plumbing deficiencies addressed under the GOI contract. Further, the wiring and the circuit breaker for the water heater and water pump appeared to be non-functioning, and its electrical wiring was not inside a conduit (Site Photo 8).

Site Photo 7. Unsafe electrical wiring and breaker

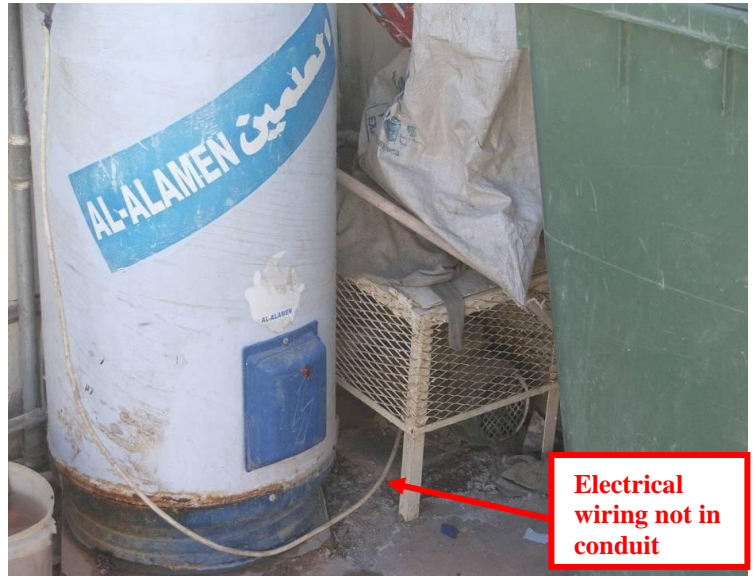
Electrical wiring not in conduit

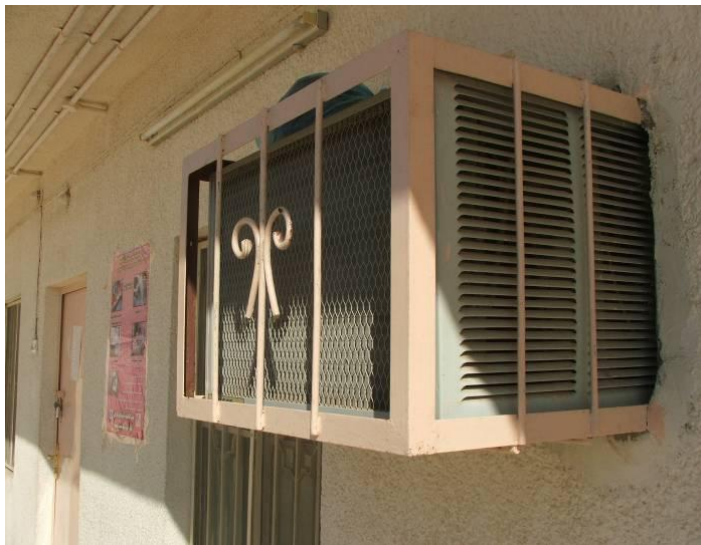
The BOQ required the contractor to provide and install four evaporative coolers, and according to USACE's final inspection report, all four evaporative coolers were delivered and installed. However, during the site visit, SIGIR only observed one window air conditioning unit (Site Photo 9). After SIGIR briefed GRD that no evaporative coolers were on site, GRD sent representatives to determine the status of the evaporative coolers. GRD subsequently provided SIGIR a photograph of the four evaporative coolers delivered to the Suroor Elementary School (Site Photo 10). In addition, GRD stated that "in October 2008, at the request of a government official, the school principal released three coolers on loan to other schools." This still leaves one evaporative cooler unit unaccounted for; however, at the time of the site visit, SIGIR was unable to inspect several rooms because they were locked and access to the roof was denied. Therefore, SIGIR cannot definitely state whether or not a single evaporative cooler unit was still at the school.

Site Photo 9. The only window air conditioner observed at the school

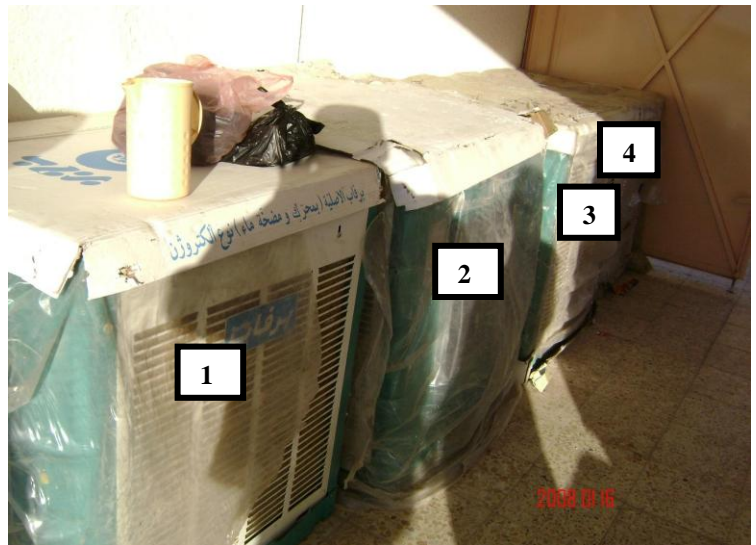
Site Photo 10. Four evaporative cooler units delivered to school (Courtesy of GRC)

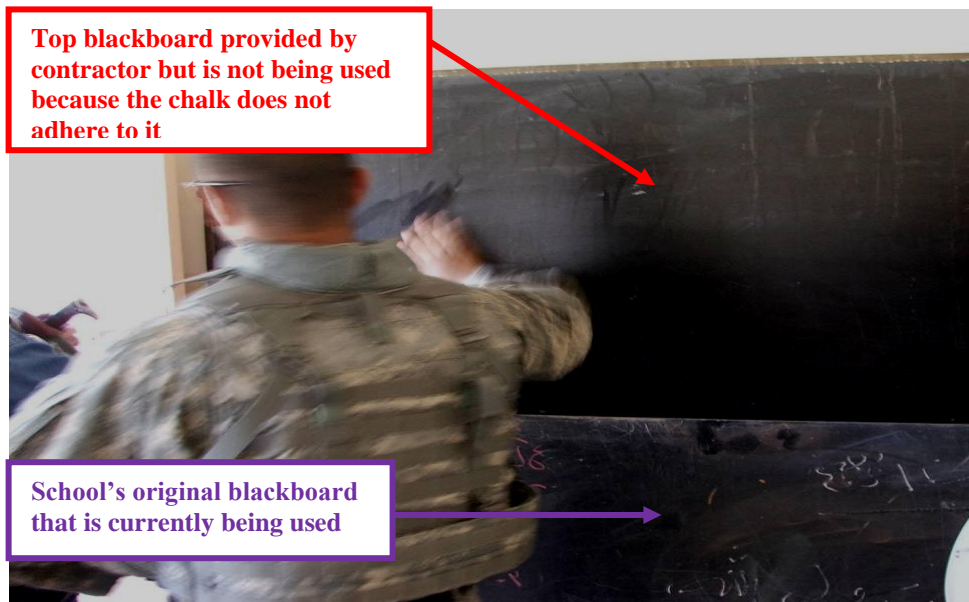
During the site visit, the school's headmaster stated the contractor provided "poor quality" blackboards. Specifically, the blackboards were not properly treated, and as a result, chalk would not adhere well to the blackboards. Consequently, the school's administration decided to use the old blackboards instead (old blackboards were hung over the newly provided blackboards) (Site Photo 11). SIGIR also concluded the newly provided blackboards were of poor quality.

Site Photo 11. New blackboard (top) Original blackboard (bottom)

SIGIR advised GRD about the contractor's poor quality blackboards. A GRC representative subsequently visited the school to inquire about the blackboards. According to GRD, the school recently received 12 new whiteboards. The school maintenance staff plans to "put all blackboards in storage and install the new whiteboards in the classrooms because most Iraqi schools are now using whiteboards." GRD did not provide a photograph of the new whiteboards.

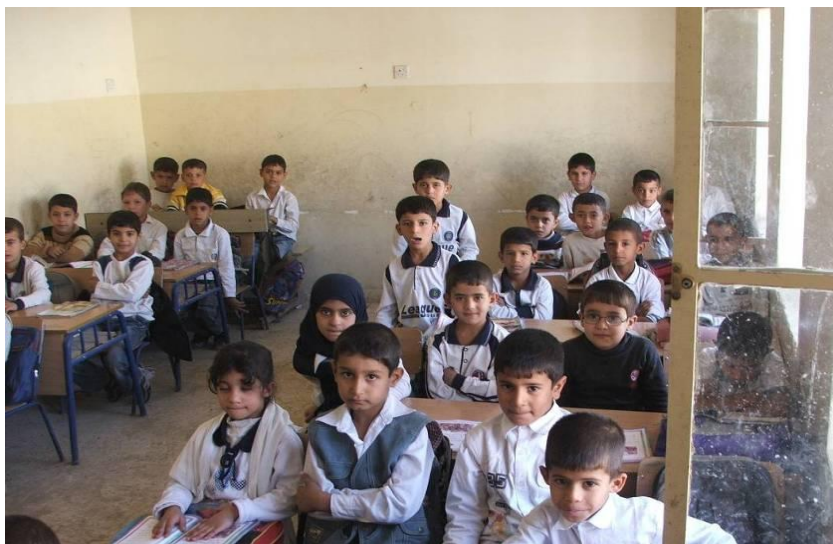
According to the school's headmaster, this school is considerably overcrowded, having to distribute approximately 1,500 students between 10 classrooms over the course of three shifts (which averages to approximately 50 students per classroom). SIGIR observed the second shift and identified the school did not have enough desks, which required some students to sit on the floor during classroom instruction (Site Photo 12). The contract's SOW only required the contractor to provide office desks, chairs, and a sofa for the administration room.

Site Photo 12. Overcrowded classroom and lack of desks

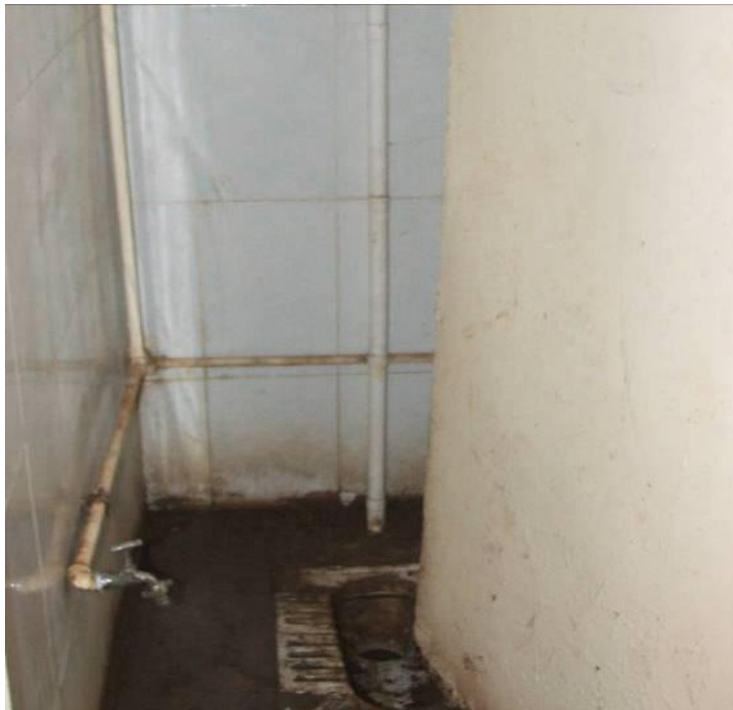
Originally, plumbing work was required by this contract; however, it was deleted once it was determined that a separate GOI funded contractor was to perform the plumbing work. At the time of the site visit, the school's unsanitary conditions presented health and environmental problems to the students and the community. For example, the existing student bathrooms are considerably undersized for a school with a daily capacity of approximately 1500 students (three shifts of approximately 500 students each). In addition, the eastern-style toilets did not have water to flush, which resulted in human waste sitting in the toilets (Site Photo 13). Further, there was no indication that any form of routine maintenance was provided for the bathrooms.

Site Photo 13. Unsanitary condition of school bathrooms

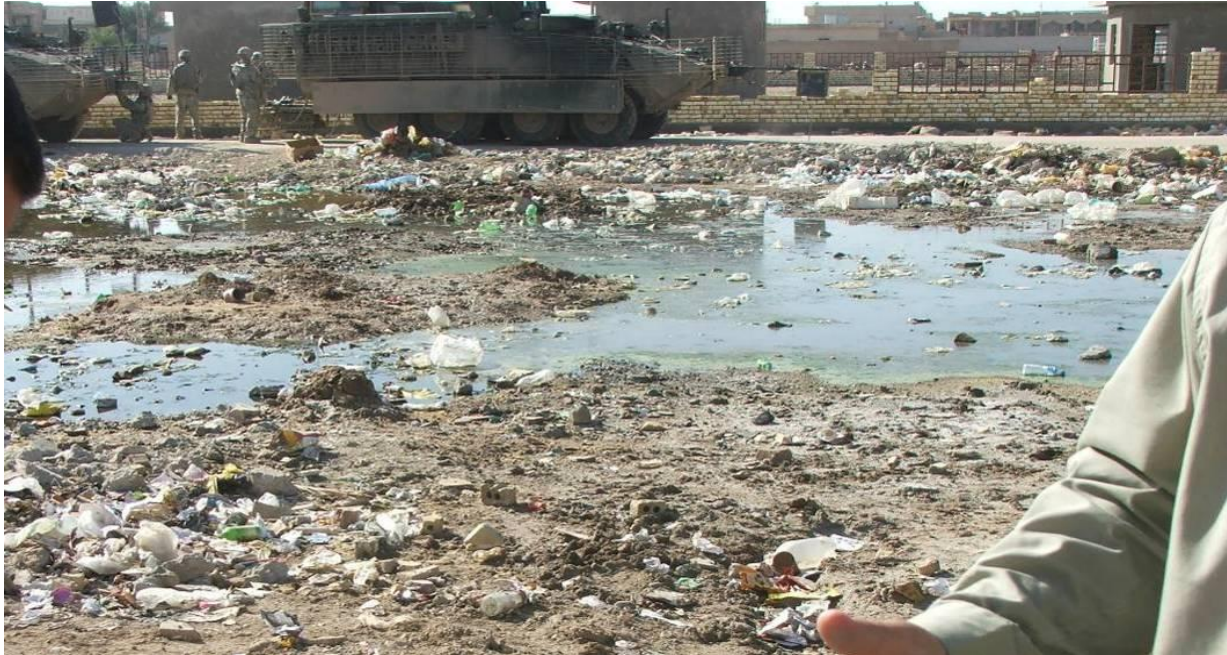
In addition, the sanitary sewer septic system's capacity is not large enough for the school, and according to the headmaster, the septic tank is full because the school does not have a septic cleaning contract. According to the headmaster, a trench was dug to allow discharge out of the full septic tank (Site Photo 14). While this provided an instant relief for the full septic tank, it resulted in large quantities of untreated sewer water being released into the neighboring areas directly bordering the school. As a result, the properties adjacent to the school grounds are unsafe and unsanitary. SIGIR observed

standing water, sewage, and trash surrounding the school. This standing water and sewage can lead to dangerous diseases, such as cholera.

Site Photo 14. Trench dug to allow discharge out of the full septic tank

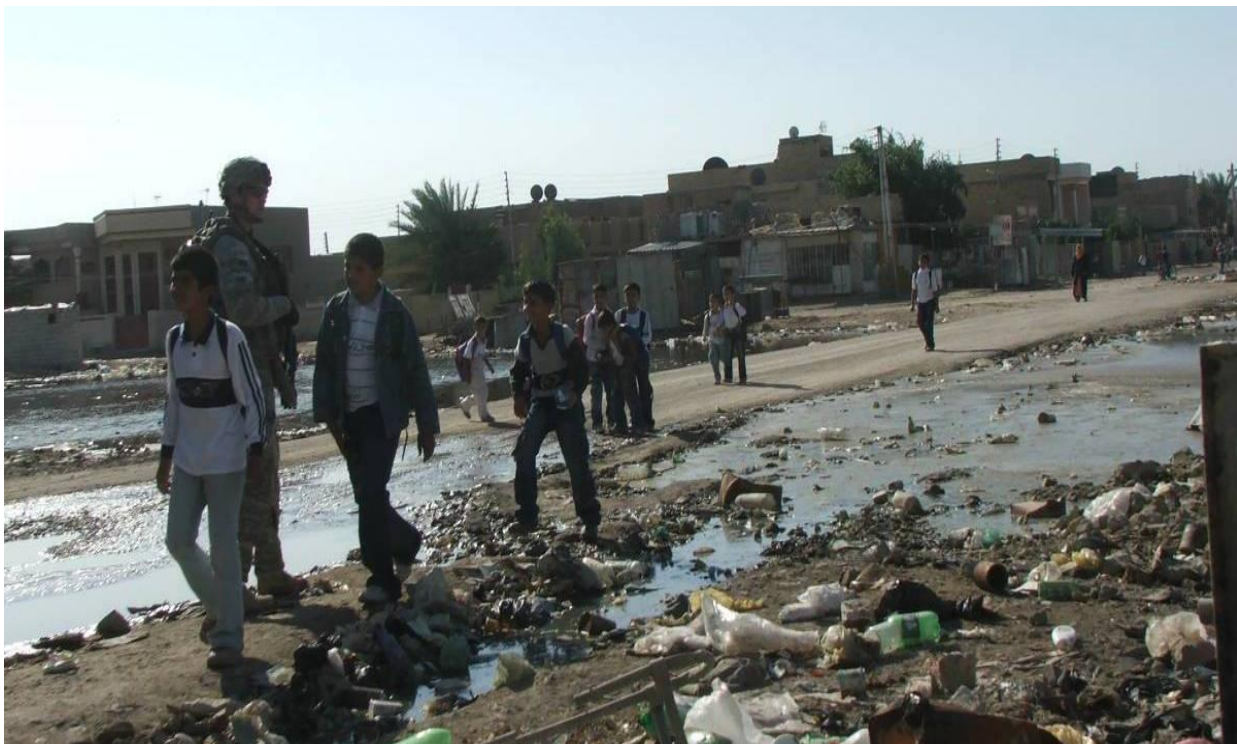
In order to avoid walking through the standing water and sewage from their homes to the school, a make-shift levee was made for the children (Site Photo 15). SIGIR had to use the levee to access this site.

Site Photo 15. Make-shift levee for students to avoid walking through standing water and sewage
